# Briefing Notes on Landslide Prevention and Mitigation Works at Po Shan, Mid-Levels

# Geotechnical Engineering Office Civil Engineering and Development Department October 2011

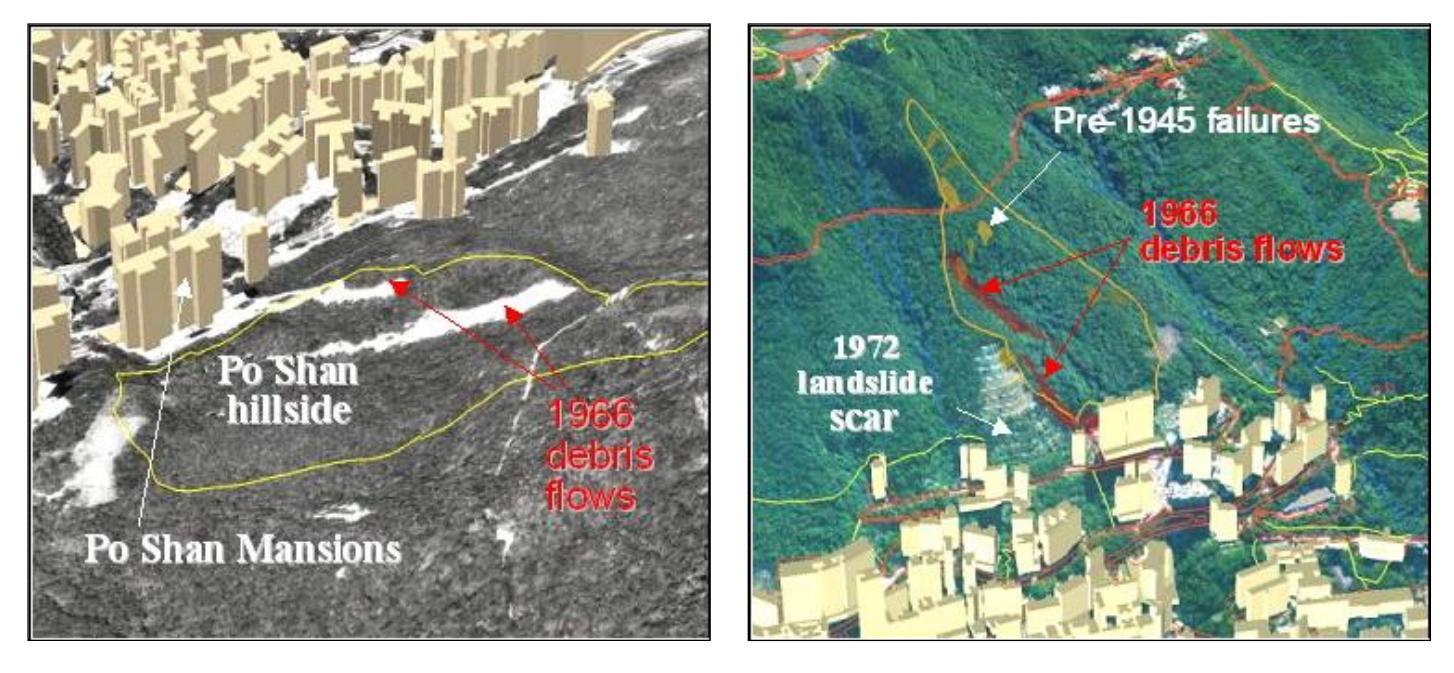
Fig. 1 Two debris flows occurred during the rainstorm of June 1966.

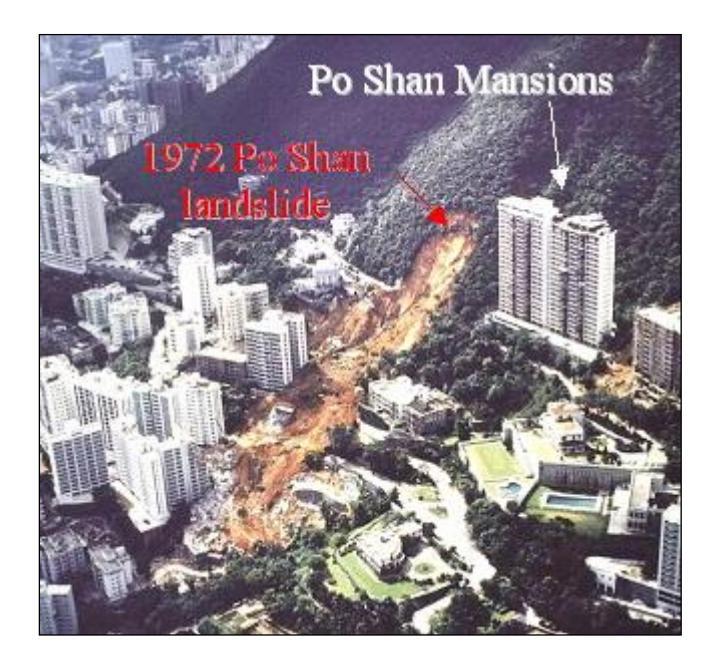
Fig. 2 The 1972 Po Shan landslide, which resulted in 67 fatalities, was caused by the construction activities at a site below Po Shan Road.

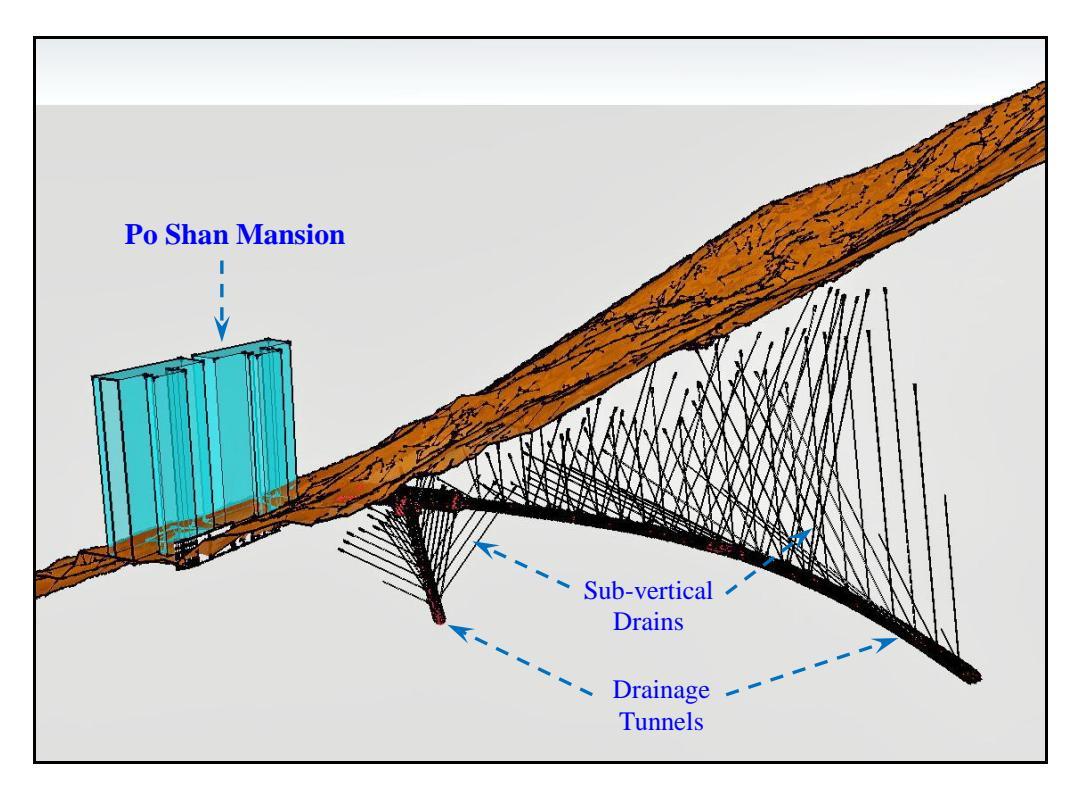
Fig. 3 Underground sub-vertical drains system

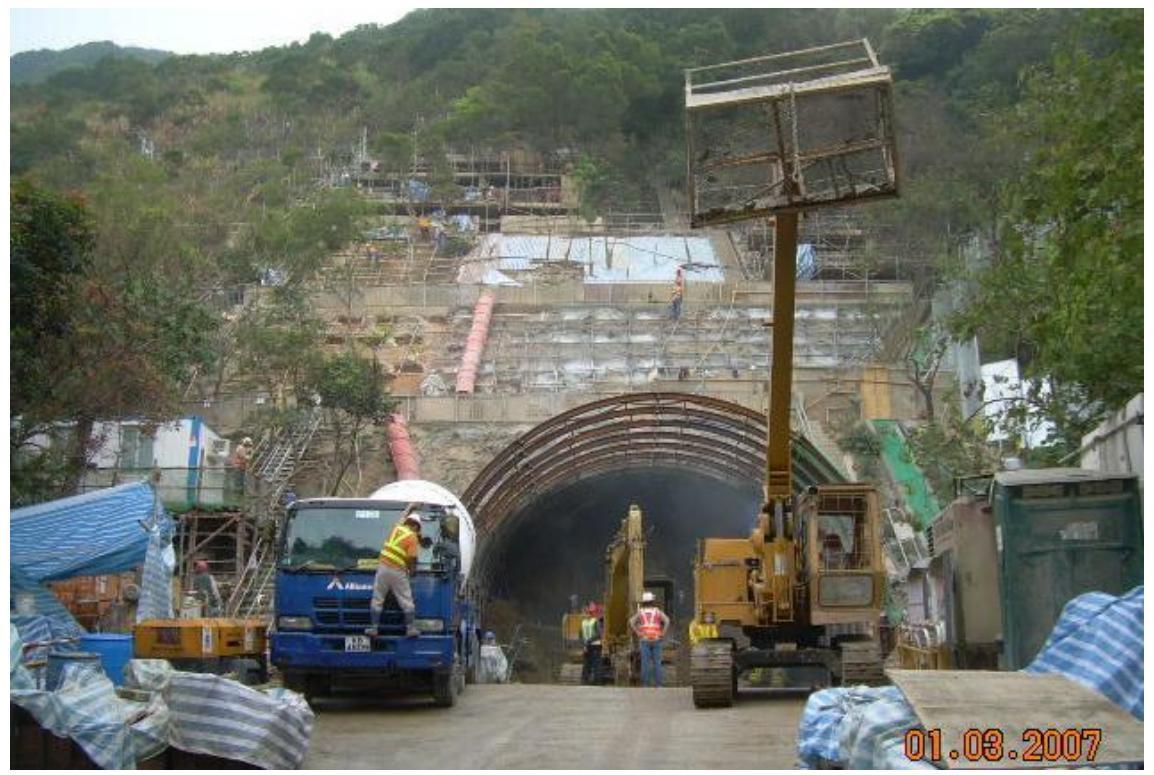
Fig. 6 Excavation of tunnel portal

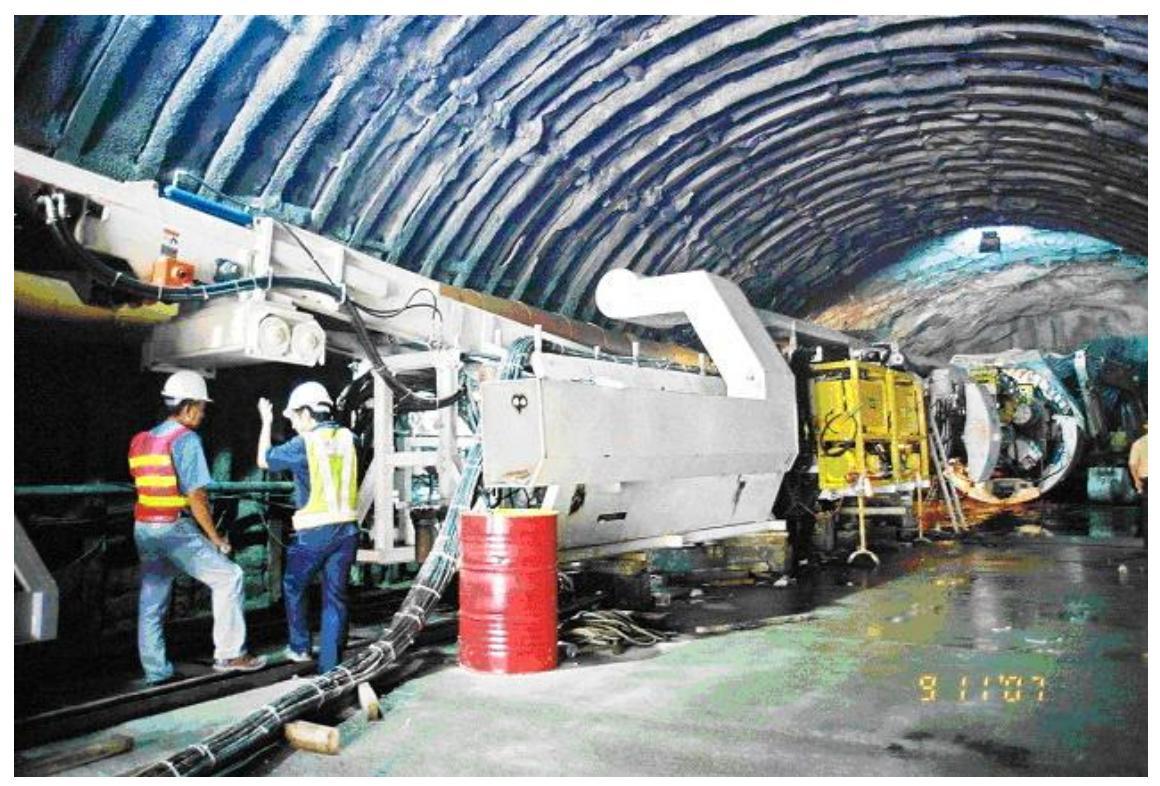
Fig. 5 TBM being assembled on site

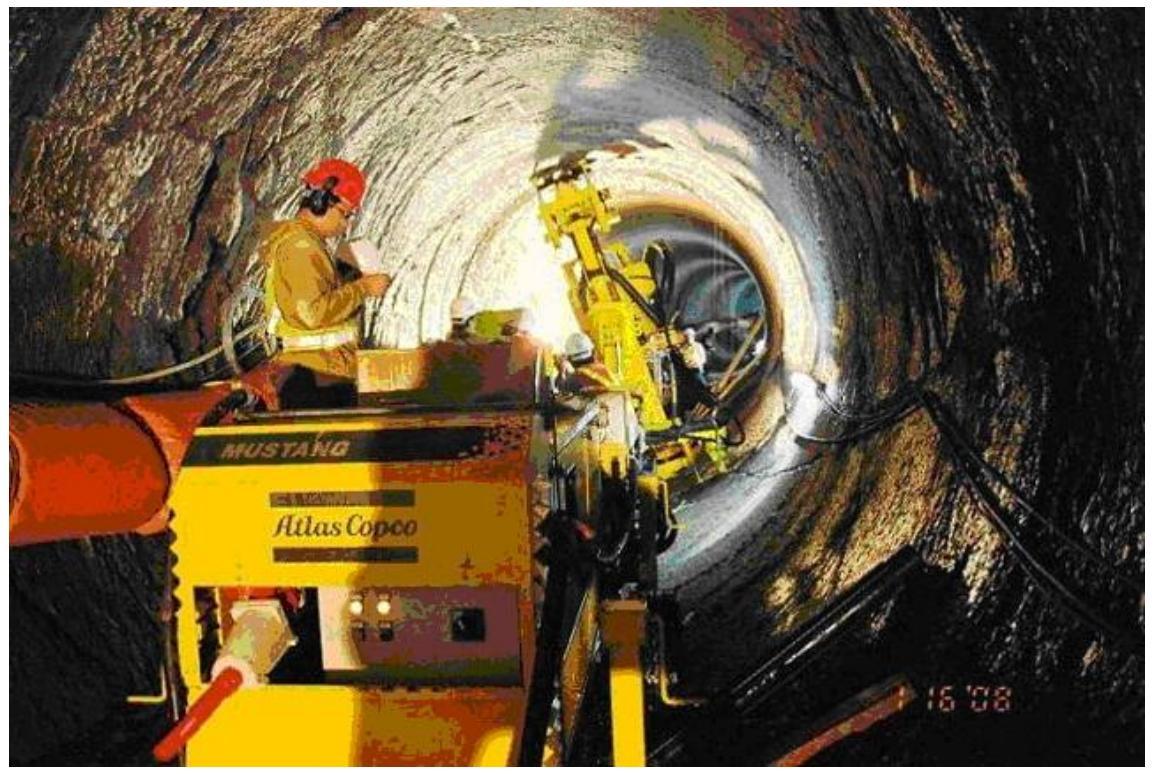
Fig. 6 Installation of sub-vertical drains

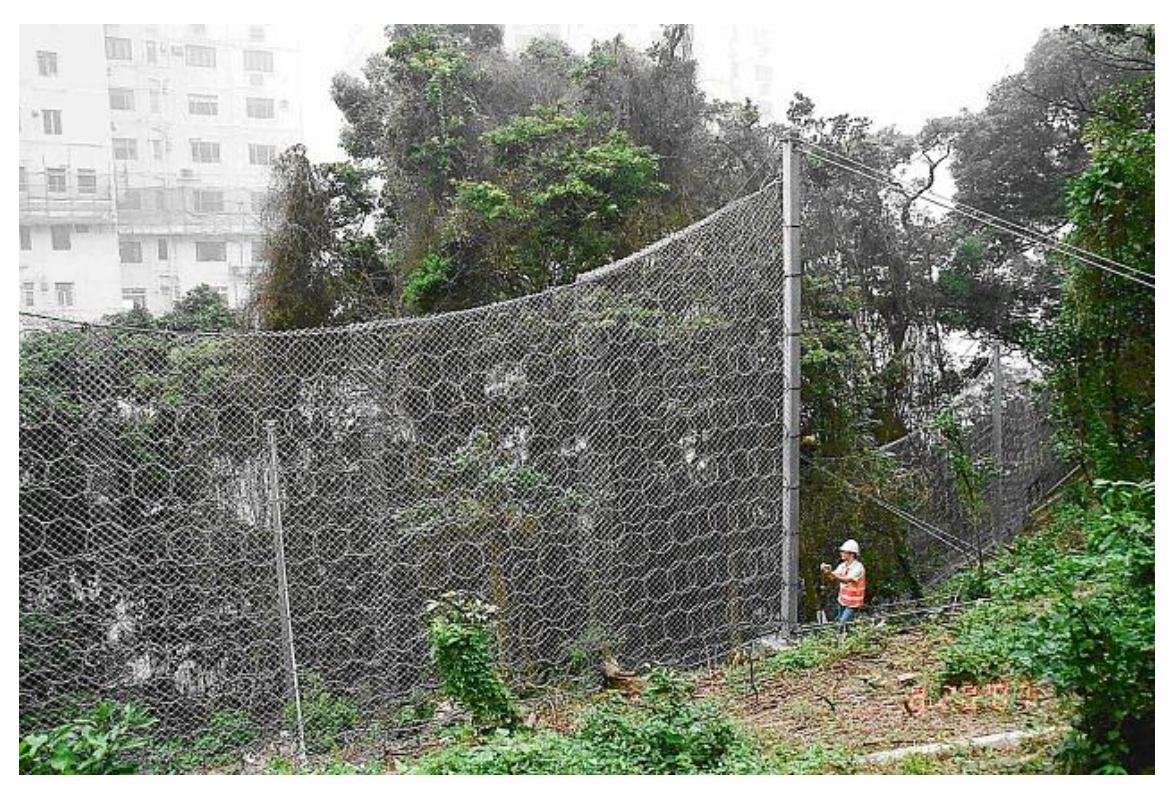
Fig. 7 Flexible barrier as part of mitigation works for shallow landslides

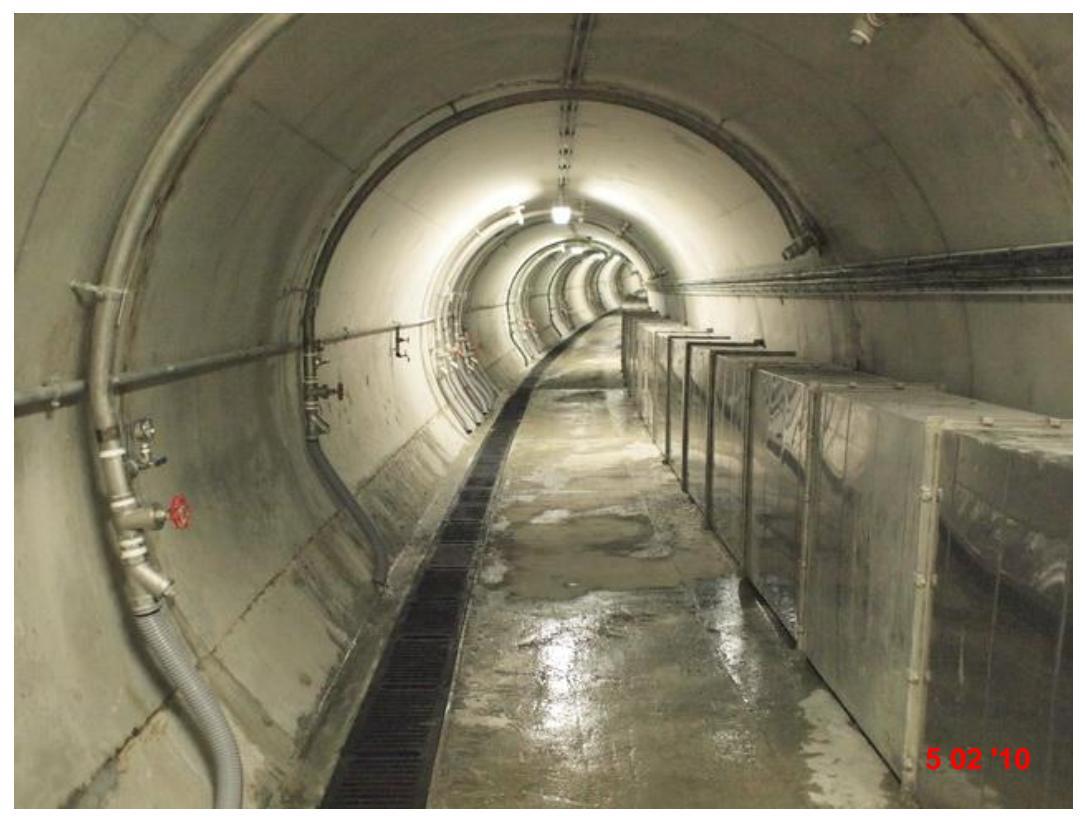
Fig. 8 Sub-vertical drains installed inside tunnel with permanent concrete lining

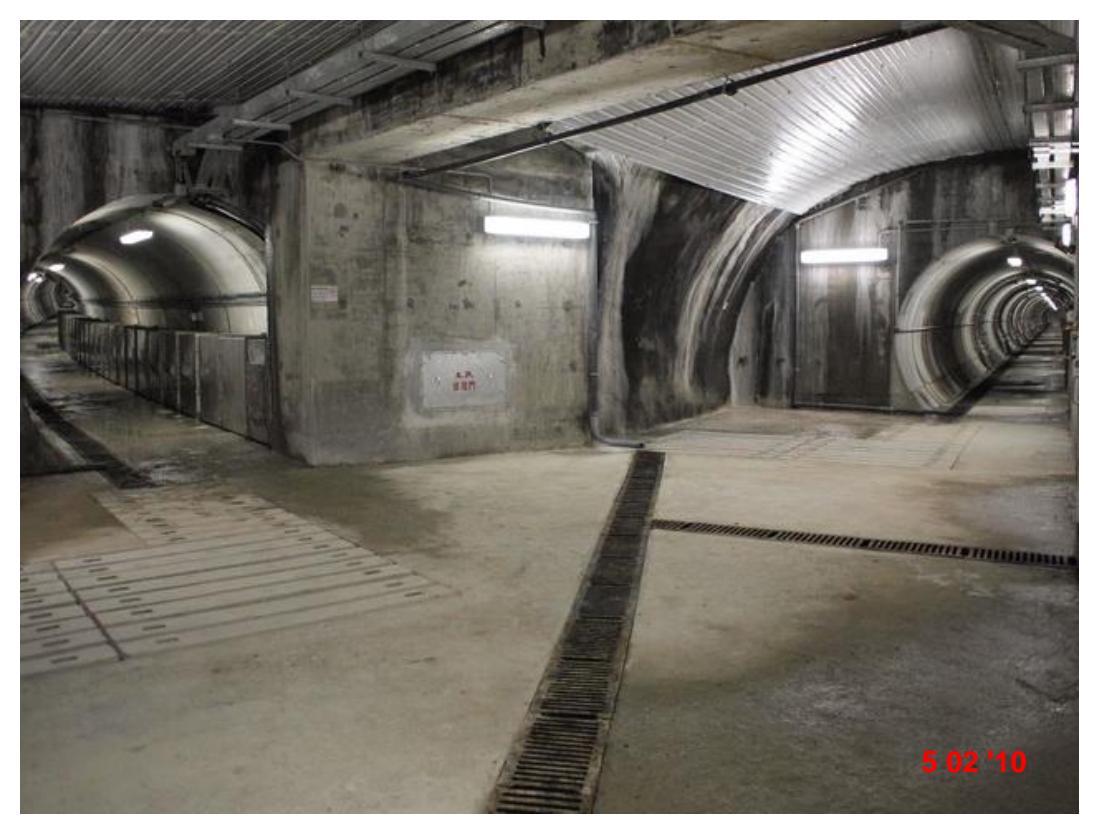
Fig. 9 Drainage tunnels - high tunnel on the left and low tunnel on the right.
